NRL/MR/7130--03-8685

Preliminary Observations Regarding LDV Scans of Panels Excited by Broadband Actuators at the U.S. Capitol

J.A. BUCARO
J. VIGNOLA
B. H. HOUSTON
A. J. ROMANO

November 7, 2003

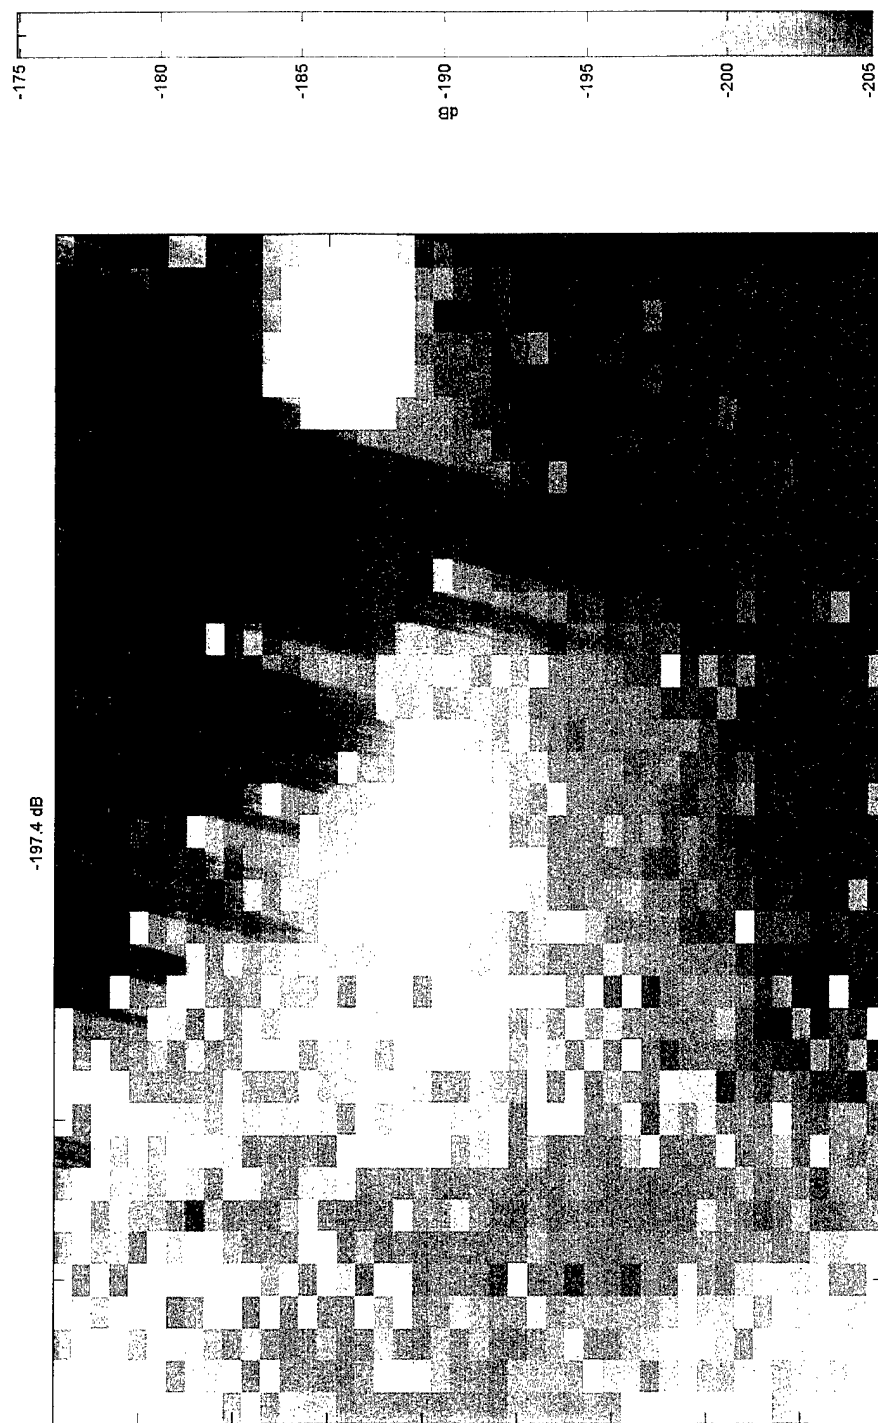
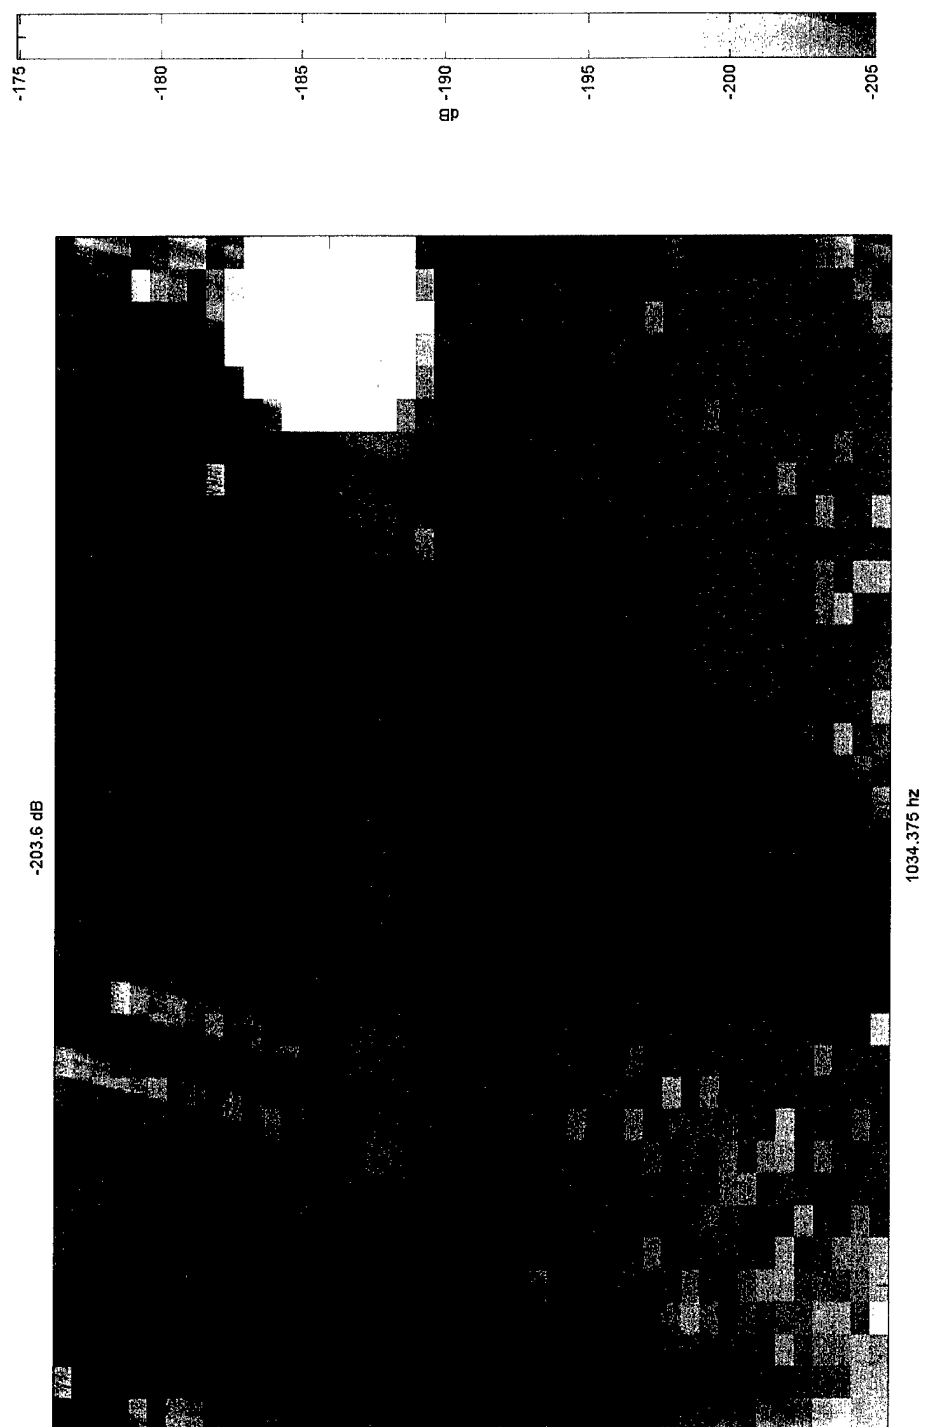
An attempt was made to combine the individual narrow-band scans into a broadband map. We did this by forming the sum over the frequency bands of the properly normalized quantity $|VV^*|$ at each spatial point. The resulting maps are shown in Figs. 4a - 4c for the full band and two partial bands, respectively. In addition to the dominant mobile patch in the upper right previously discussed, there appears to be additional larger areas with levels lower by some 30dB. As can be seen in Figs. 4b and 4c, these seem to be dependent on frequency. At this point, we are not certain whether these broader features are actually related to increased mobility of the structure or a signal to noise related artifact.
